NASA TECHNICAL
MEMORANDUM

NASA TM X-64810

MSFC SKYLAB AIRLOCK MODULE
Vol. II

Skylab Program Office

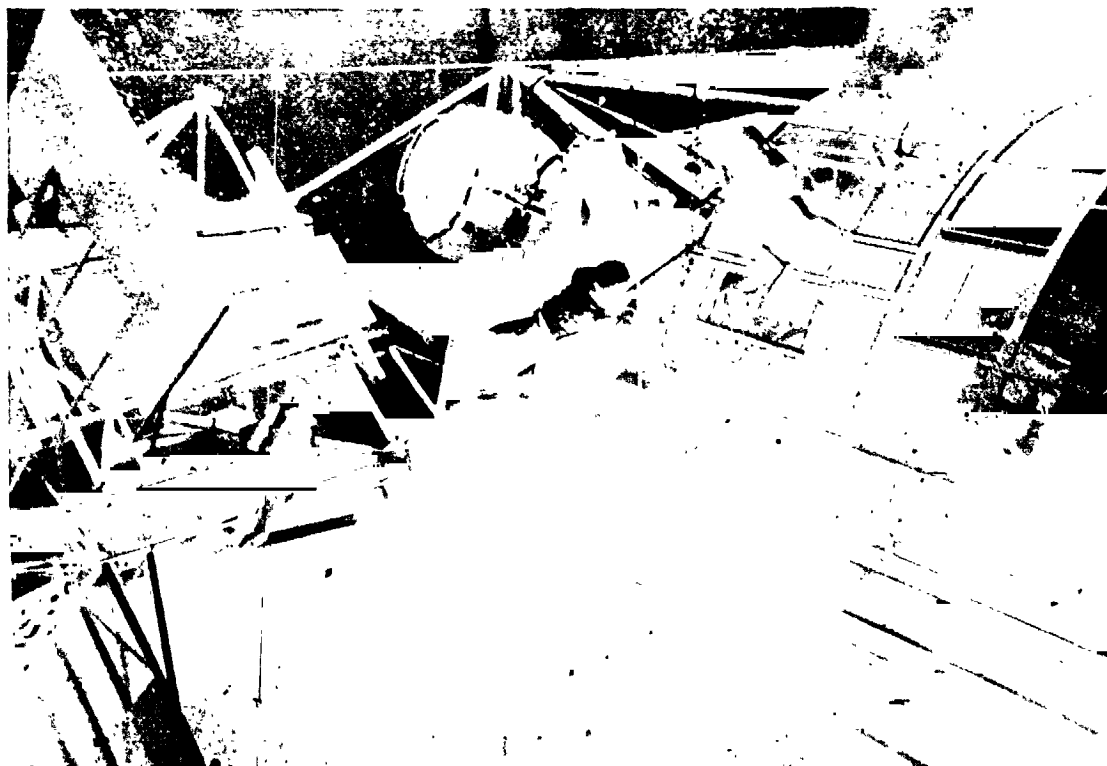
FIGURE 2.13-15 NEUTRAL BUOYANCY TRAINER - CREW TRAINING

During this time, five 3-man crews were trained for EVA. WIF training capacity is two suited crewmen, so crew members were rotated through the facility. All training periods were covered by appropriate MDAC-E personnel.

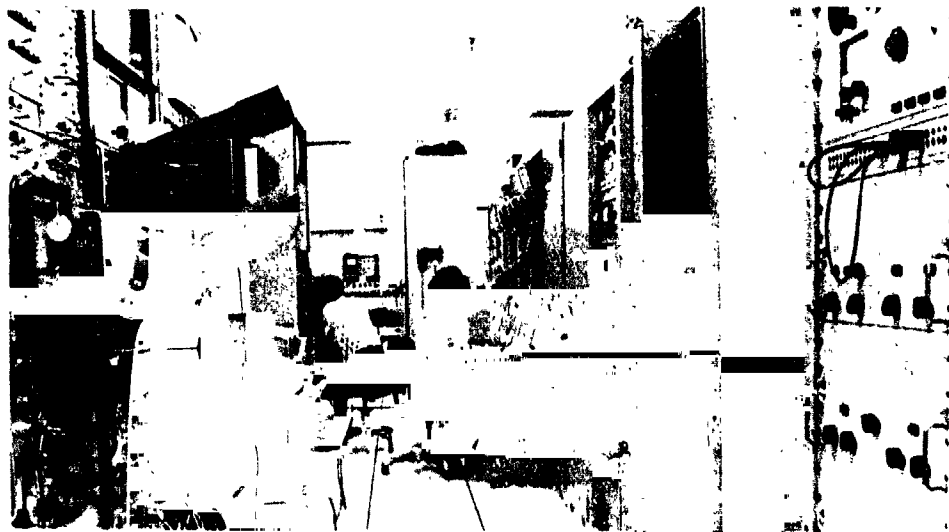
Data Acquisition System (DAS)

The DAS had the capability to receive telemetry transmission from the STU AM/OWS/ATM/MDA simulator or downlink transmission from the Skylab via the quad-helix tracking antenna whenever Skylab was in line-of-sight. The telemetry data was received by the five receivers, three tuned to the AM frequencies and two tuned to the ATM frequencies. Output of the receivers was recorded on magnetic tape and also coupled to the MSFTP-I (-III) for decommutation. After decommutation by the MSFTP, the telemetry data was recorded on the analog or event recorders and also transferred to the data processor where it was processed by computer and a hard copy was printed by a hi-speed printer.

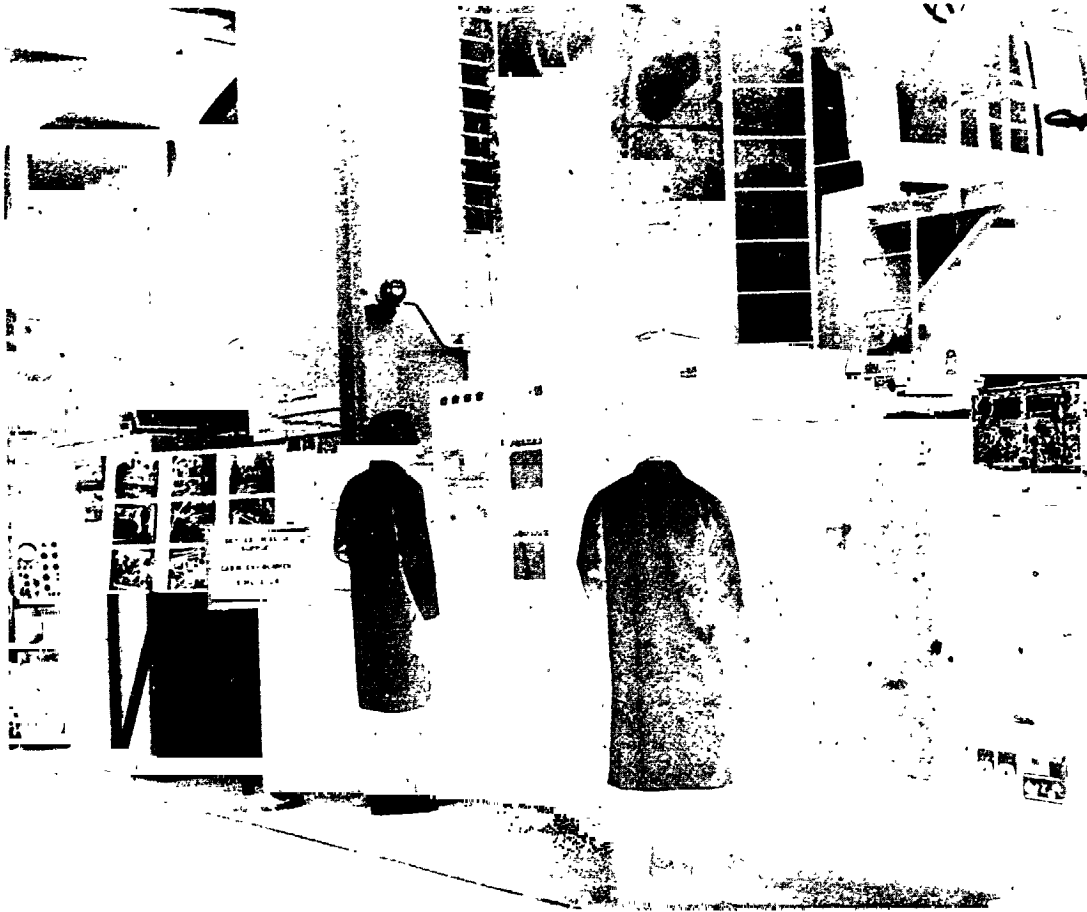
FIGURE 7-14 ECS/TCS STU CABIN ENVIRONMENT CHAMBER

Location - The ECS/TCS STU was located in the McDonnell Douglas Space Simulation Laboratories in St. Louis. Figures 7-14 and 7-15 depict the ECS/TCS set-up which utilized the 18-ft. diameter chamber as the cabin simulator and a smaller five-foot diameter chamber to simulate the external environment.
